**Five Counties Salmonid Conservation Program
Coastal Conservancy Grant Agreement No. 03-051**

FINAL REPORT

Exhibit 3: Program Report on Previously Funded Projects

Project Summary

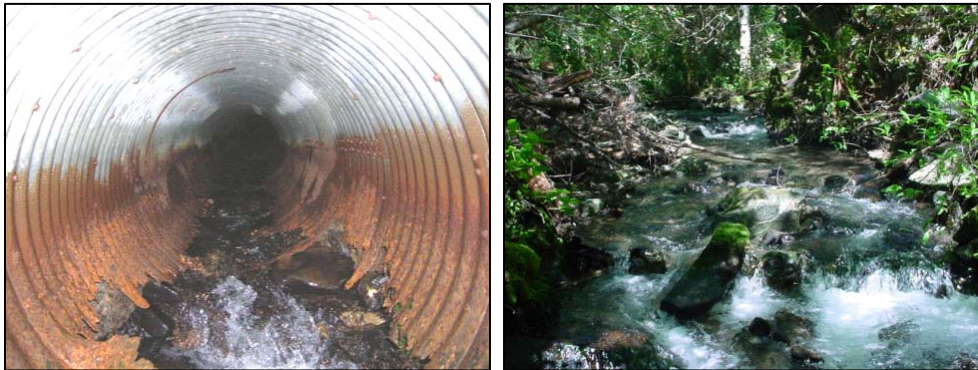
Griffin Creek #2

Outlet of 36" Culvert

This project is located within the Smith River watershed, approximately 35 miles northeast of Crescent City in Del Norte County on Oregon Mountain Road (County Road #324). Griffin Creek currently hosts populations of resident Coastal cutthroat trout in the upstream reaches and is an important spawning and rearing tributary for coho and steelhead with approximately 3.7 miles of high quality habitat. It is the second highest priority in Del Norte County (assessed during the second round of County Road migration barrier inventory in coastal watersheds - Ross Taylor & Associates, 2003-2004). The existing 36" diameter, 120-foot long culvert was not assessed with FishXing software due to safety issues, but was identified as a complete barrier to all age classes during all migration flows because of the buried inlet and perched, degraded outlet.

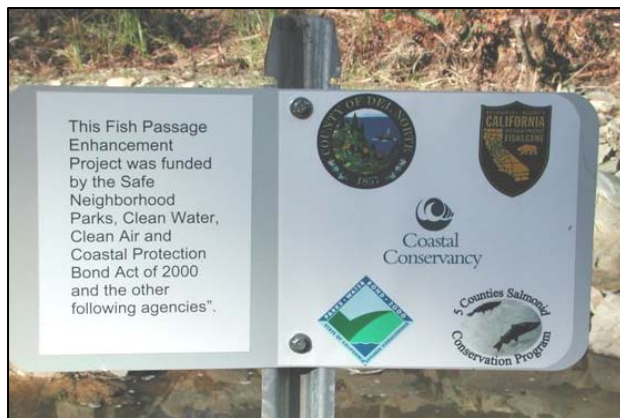
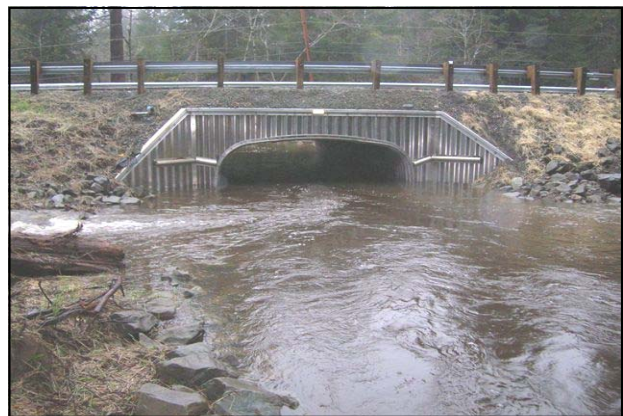
Yonkers Creek Wonderstump Road—Del Norte County

Due to the higher costs of relocating a 12-inch and 24-inch waterline beneath the road if a bridge had been constructed, the design option of an arched culvert was selected. The waterlines were re-installed in the culvert roadfill after project construction. This project was partially funded for construction under the 2004/2005 CDFG FRGP and was included in the 2005 CDFG Mitigated Negative Declaration. All other permits (1602, 404, 401 and a Del Norte County grading

This project is located on Wonderstump Road in Del Norte County and crosses a small coastal tributary to Lake Earl, just north of Crescent City. This project was designed in 2004 and constructed in 2006 within the timeframe of this grant. It now provides unimpeded access for coho, steelhead and Coastal cutthroat trout to 1.7 miles of upstream spawning and rearing habitat. FishXing analysis determined the 6-foot diameter, 61-foot long culvert (with perched outlet and steep slope) as a complete barrier to adult Coastal cutthroat and all juvenile species due to the excessive velocities within the culvert and outlet barrier. It was replaced with a 15-foot wide by 8-foot high natural bottom aluminum arch structure, designed under the "stream simulation" design method (sizing the structure at 1.45 times the active channel width). This crossing was the last high priority barrier identified in the first run of the Del Norte County barrier inventory (Taylor & Associates, 2000).

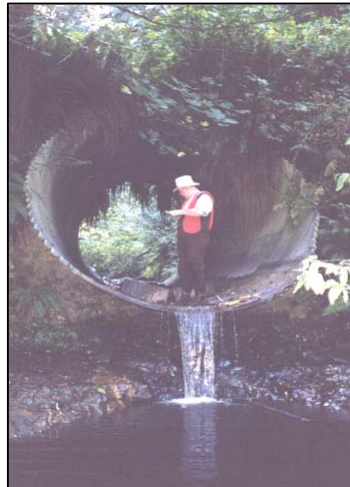
Graham Gulch is a tributary to Freshwater Creek in Humboldt County. The project was constructed in 2005 and provides unimpeded access to 2.5 miles of habitat for coho, steelhead and Coastal cutthroat trout. The 13.25-foot diameter, 60.5-foot long metal culvert was replaced with a 18-foot wide, 9-foot high corrugated metal arch culvert set on concrete footings, allowing for complete passage of all species and life stages and the 100-year flows. The perched outlet, with ineffective steel-ramp baffles, was the primary migration barrier for adults and juveniles.

Observations were made on numerous occasions, prior to replacement, of both age classes making failed attempts at the culvert outlet. This project received funding from 2003/2004 CDFG FRGP and was included in the 2004 Mitigated Negative Declaration. This grant agreement funded the site surveying, hydraulic analysis, and portions of the civil engineering. A final report on project construction is included on the submitted Final Report CD.

Before & After

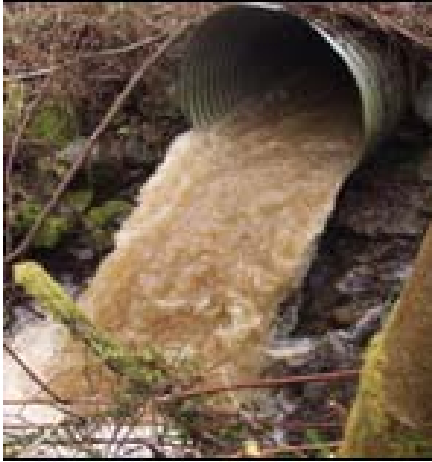
Rocky Gulch
Outlet at High Flows
Humboldt County

Rocky Gulch is a 1.5 square mile watershed that drains into North Humboldt Bay, approximately six miles north of Eureka. It historically supported coho salmon and steelhead populations, but past timber and agricultural land-uses caused extirpation of these populations by the early 1960's. The County maintained crossing (part of the "*Rocky Gulch Salmonid Access and Habitat Restoration Project*") is located on Old Arcata Road approximately 5,000 feet upstream of the confluence with the Bay. The crossing consists of two 36-inch diameter, 48-foot long culverts. They are undersized, with a capacity for less than a 2-year storm event and the high –flows through the culverts during migration flows result in a velocity barrier for all age classes and species. The current design options are to replace the culverts with either a countersunk metal box or pipe-arch culvert

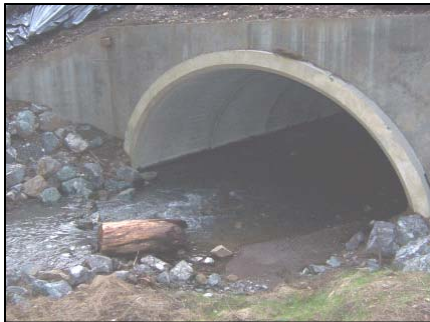
Albion River

Both constructed in 2006

primarily due to the excessive velocities over the concrete culvert linings, the lack of depth at lower migration flows, and the leap required to enter the culverts. The culverts were replaced in 2006 with open-bottom, pre-manufactured concrete arch structures, providing for full passage of all species and life stages and the 100-year flows. This project has allowed access to approximately five miles of historic spawning and rearing habitat upstream of the crossings, approximately one mile on Marsh Creek and four miles on the Albion River. Both projects were constructed at the same time due to their proximity in location as well as their high priority rankings (#3 and #5 in Mendocino County). Conducting the environmental review and permitting for both projects at once was cost effective and sequential implementation reduced the overall environmental impact and construction costs. This grant agreement funded the following design elements: site surveying, geotechnical analysis, and the civil and structural engineering. The project was

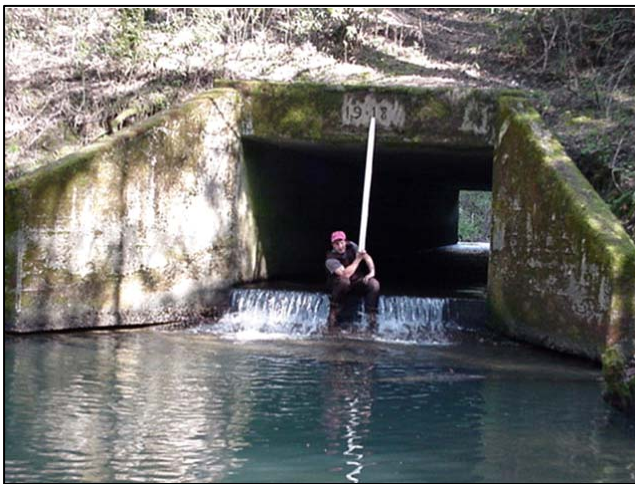
Ryan Creek is located in the Outlet Creek sub-watershed of the North Fork Eel River. Outlet Creek one of the highest priority coho watersheds identified in the *Recovery Strategy for California Coho Salmon*. The existing culvert is a 10-foot wide, 6-foot high, 82-foot long concrete box and is proposed for full replacement with a 19-foot wide, 82-foot long concrete arch structure set on concrete footings. The existing culvert was assessed as 20% passable for adults coho, Chinook, and steelhead and as a complete barrier for all age classes of juveniles due to the excessive velocities and outlet jump. The broken concrete apron at the outlet is also a major impediment to fish migration. Approximately 500 feet of good quality habitat exists between the county Ryan Creek crossing and the two Caltrans crossings (North and South Fork) located upstream (all of these crossings were designed under this grant agreement and are described below). CDFG surveyed the SF in 1995 (NF was denied entry) and estimated 6,000 feet of upstream habitat. During the Caltrans District 1 Inventory there was estimated to be 9,000 feet of upstream habitat. When all of the barriers in this portion of the watershed (including a private crossing on the SF that was also designed under this grant agreement) are treated, approximately 15,500 feet or 3 miles will be made accessible to Chinook and coho salmon and steelhead.

Ryan Creek
Ryan Creek Road—
Tributary to Outlet
Creek
Mendocino County

Design elements funded under this grant agreement for the county project included the hydraulic analysis, site surveying, and a portion of the structural engineering. Mendocino County conducted CEQA for this project and a Mitigated Negative Declaration was filed in March 2003. All construction permits have been secured by the County and CDFG and the project is scheduled for constructed in 2007. It has funding from the 2001/2002 CDFG FRGP and potentially the Coastal Conservancy and Steelhead Restoration Card Program. Design plans are included as Attachment 4 and on the submitted Final Report CD.

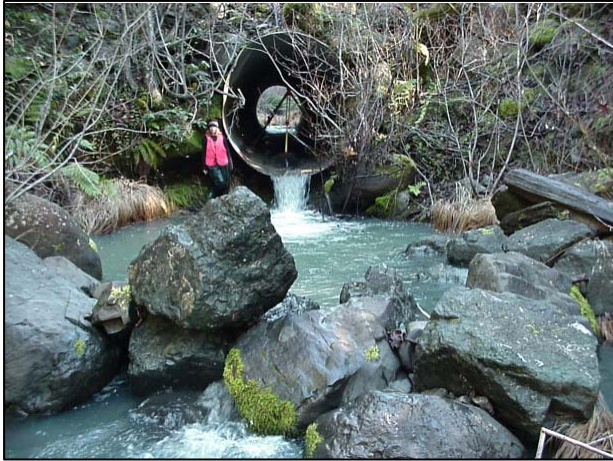
This project is located at the Orr Springs Road crossing of Dark Gulch, a tributary to South Fork Big River. The existing culvert is a 7-foot diameter, 90-foot long corrugated steel pipe set at 3.29% slope. The culvert is in poor condition, rusted through the bottom in several places and is a complete barrier for all species and

Orr Springs Road—Tributary to Big River

age classes of salmonids, due mostly to the excessive velocities within the culvert, lack of depth at the lower migration flows, and the leap required to enter the culvert. The culvert is retrofit with a concrete lining and boulder weir placement at the outlet. However, the modification has failed to raise the elevation of the outlet pool and still results in a 1.8 foot drop. Implementation of this project will restore access to approximately 1 mile of habitat for coho salmon and steelhead. Dark Gulch flows into the South Fork Big River just below the crossing. The upstream habitat consists of a dense riparian canopy of conifers and hardwoods and

small bedrock-formed pools. Replacement of the culvert with a bridge that provides for passage of adults and juveniles is the current conceptual design. The project is 60% designed and not scheduled for construction until at least 2009. Final design could not be completed in the timeframe under this Grant Agreement and additional funding for completing design and construction will be sought under other federal and state grant sources. The geotechnical analysis was funded under a CDFG FRGP grant through the 5C Program and this grant agreement funded the following design elements: site surveying, hydraulic analysis and modeling of the proposed crossing for the 100-year flows.

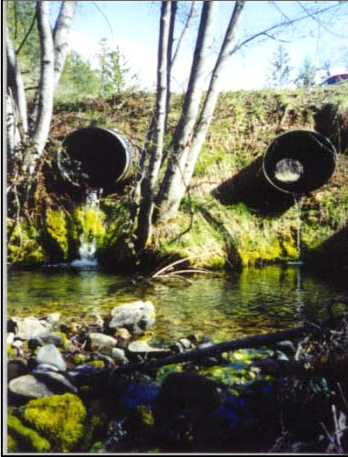
Little Browns Creek
Roundy Road
Tributary to Weaver Creek
Trinity County

The existing crossing consists of three, 4-foot diameter, 50-foot long metal culverts all of which are undersized with ~8-foot jumps at their outlets. The proposed design consists of a 30-foot long concrete bridge (developed by TCDOT engineering staff). Consulting hydrologist, Mike Love, was contracted (under a matching grant source) to assist with the upstream grade control design. A roughened channel consisting of ten rock weir structures and engineered streambed material was developed. The permitting for this project is currently in progress. A categorical exemption under Section 15333 was prepared and filed in December 2006 and the ACOE 404 notification and 401 water quality certification were filed in March 2007. Site visits were held on April 13, 2007 with David Ammerman (ACOE) and Jan Smith (DOT) to discuss the 404 permit and on April 23, 2007 with Mike Harris (CDFG) to discuss the stream alteration

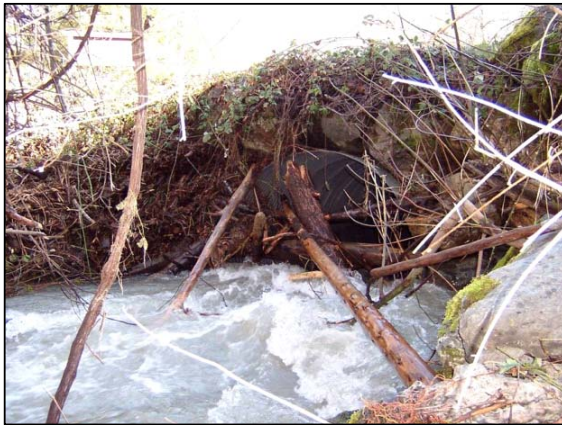
Solider Creek in February 2004
Dutch Creek Road

ineffective baffles and outlet jumps. They would often plug with woody debris during large storms, resulting in flooding of nearby private properties, diversion and sediment delivery down the roads, and repeated maintenance issues/costs for the TCDOT. The removal of the two barriers has provided access to approximately 2 miles of good quality rearing habitat for coho and steelhead. These projects were simultaneously designed and implemented because of their proximity as well as their high priority rankings (#7 and #8 in Trinity County). A single CEQA/NEPA document addressing both projects was completed and permitting fees for one construction application were substantially less than the fees for separate projects. The sequential implementation of these projects also reduced the environmental impacts and construction costs were reduced due to: one-time mobilization of equipment and crews, simpler contract management, and lower engineering and construction costs. Geotechnical analysis for both sites was completed in January 2004 under a 5C Program grant (CDFG). The Trinity County Building and Development Services staff completed the civil and structural engineering and hydraulic analysis with assistance from the TCDOT engineering staff.

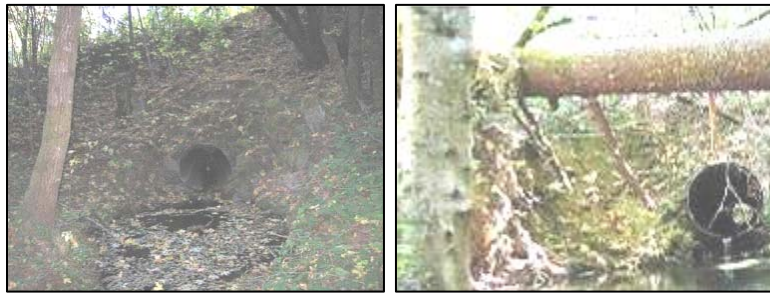
South Fork Ryan Creek—Hamman Driveway Culverts
Southerly Culvert Northerly Culvert
Tributary to Outlet Creek

The design portion of this project was completed by Prunuske Chatham, Inc. in conjunction with the North Fork and South Fork Ryan Creek Fish Passage Improvement Project designs. The crossing is located approximately six miles north of Willits in Mendocino County and is a private driveway over the South Fork of Ryan Creek (~300 feet upstream of the SF Caltrans crossing). Refer to the *South Fork Ryan Creek James L. Hamman Driveway Crossing Scoping Report for Fish Passage Improvement* included on the submitted Final Report CD and the discussion below for the North Fork and South Fork Ryan Creek Fish Passage Improvement Projects for more detail. Design plans are included as Attachment 8 and on the submitted Final Report CD.

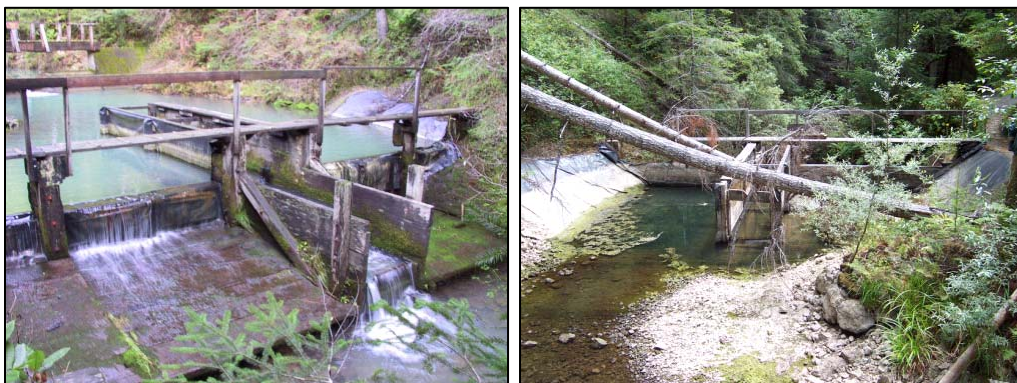
North Fork Caspar Creek

Wood dams & fish ladder Low flow between ladders & weir dams
Jackson Demonstration State Forest—Mendocino County

The goal of this project was to facilitate USFS Redwood Sciences Lab (RSL) and CDF Jackson Demonstration State Forest staff in designing replacement structures for the North and South Fork Caspar Creek fish ladders. The watershed hosts populations of Central California Coast coho salmon and Northern California steelhead which are listed as endangered and threatened, respectively. A design of replacement ladders, other "fishways" that would improve passage for both adults and juveniles without disturbing the integrity of current data collection, specifically not backwatering the V-notch weirs used to measure watershed flows, was the primary design criteria. The Caspar Creek watershed is located within the Jackson Demonstration State Forest, approximately five miles south of Fort Bragg in Mendocino County. For the last forty years, stream flow and suspended sediment have been monitored continuously as part of a paired-watershed study. The project sites consist of concrete V-notch flow-gauging weir dams, redwood dams that regulate the water surface beneath the weirs, and wooden fish ladders. The existing wooden dams and fish ladders are in poor condition with 90% of the stream flow leaking through the structures during low summer flows, trapping fish upstream until the fall rains. In May 2001, Robert Floerke (Regional Manager, CDFG Central Coast Region) submitted a Memorandum to CDF that the existing ladders were a partial barrier to fish passage and recommended their replacement. Jeffrey Jahn, NMFS biologist, issued a biological opinion in 2003 that covered the weir pond cleanouts (conducted bi-annually by CDF/RSL as part of the study) and the replacement of the ladders (when designed). From 2001 to 2004, no progress was made in developing a design for the new ladders. In order to expedite development of this project, the Coastal Conservancy recommended the project for inclusion in this grant's work program. The Conservancy also authorized disbursement of \$600,000 to CDF in May 18, 2005 for the purpose of implementing the project following successful completion of the design. From March 2005 to February 2007, 5C staff administered the preparation of the existing final design (concrete ladder with low flow sluice gates & labyrinth weir, roughened channel, and monitoring capability) for full replacement of both redwood fish ladders. The design was prepared by: Winzler & Kelly Consulting Engineers (W/K), Michael Love & Associates, and Taber Consultants. Unfortunately, this process was hampered by extensive and often late-to-arrive project recommendations from both NOAA staff and RSL.

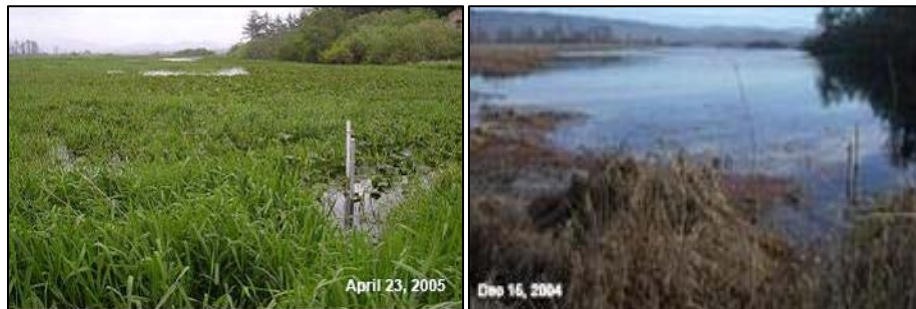
Yontocket Slough

Reed canary grass in the Slough

slough by this invasive species. It prohibits growth of native riparian vegetation and results in decreased channel capacity, making the slough impassable for various fish species, while additionally limiting the availability of quality rearing habitat. Two culverts on Pala Road, managed by California State Parks, have also limited access of anadromous salmonids to this important habitat for over 20 years. The culverts have created a large depositional reach of fine sediments and have disconnected the slough from the Smith River estuarine tidal influence. The design element funded under this grant agreement was completion of the sediment coring and analysis of deposited sediments within Yontocket Slough. The drilling/coring identified the level of sediment aggradation from flood events, along with the strata associated with pre-1880's tribal cultural deposits (Yontocket was the site of a large Native American village). This information has given the agencies involved in the project (CDFG & State Parks) a starting point for completing final design and permitting for construction. 5C staff developed a contract with Michael Love & Associates, the prime consultant responsible for completing and submitting required permit applications and obtaining archeological clearance as required, for the project. Love contracted with Pacific Watershed Associates (PWA) to perform the coring fieldwork in October 2005 and coordinated with the Smith River Rancheria to provide tribal cultural monitors during the coring. The stratigraphic investigation report findings were incorporated into three alternatives for improving aquatic habitat and fish passage in the slough. Currently, State Parks and CDFG are negotiating a potential land swap for this project. State Parks is also interested in a fourth alternative that involves large-scale excavation, with excavation depths based on the sediment coring results from PWA. The coring report, funded under this grant agreement, is included on the submitted Final Report CD, as is a Final Report on the design of the project (funded by matching grant sources).

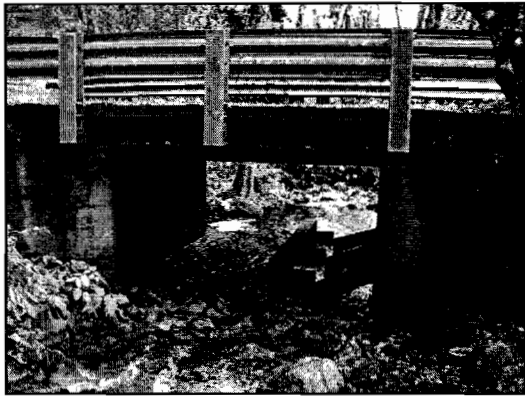
Photo 1

Conner Creek #1 Looking Downstream

The existing structure at Culvert #1 is a RCB with dimensions 14.3 feet wide by 5.75 feet high as shown in Photo 1. To facilitate fish passage, one foot high baffles are present in the right half of the box. Taylor et al. (2002) state that Culvert #1 fails to meet passage criteria for all species of adult salmonids and all age classes of juveniles due to excessive flow velocities through the culvert along with a drop into the outlet pool in excess of two feet. Additional information on this culvert is provided in the Design Criteria section of this report, including migration flows and other passage criteria along with site photographs (Appendix A).

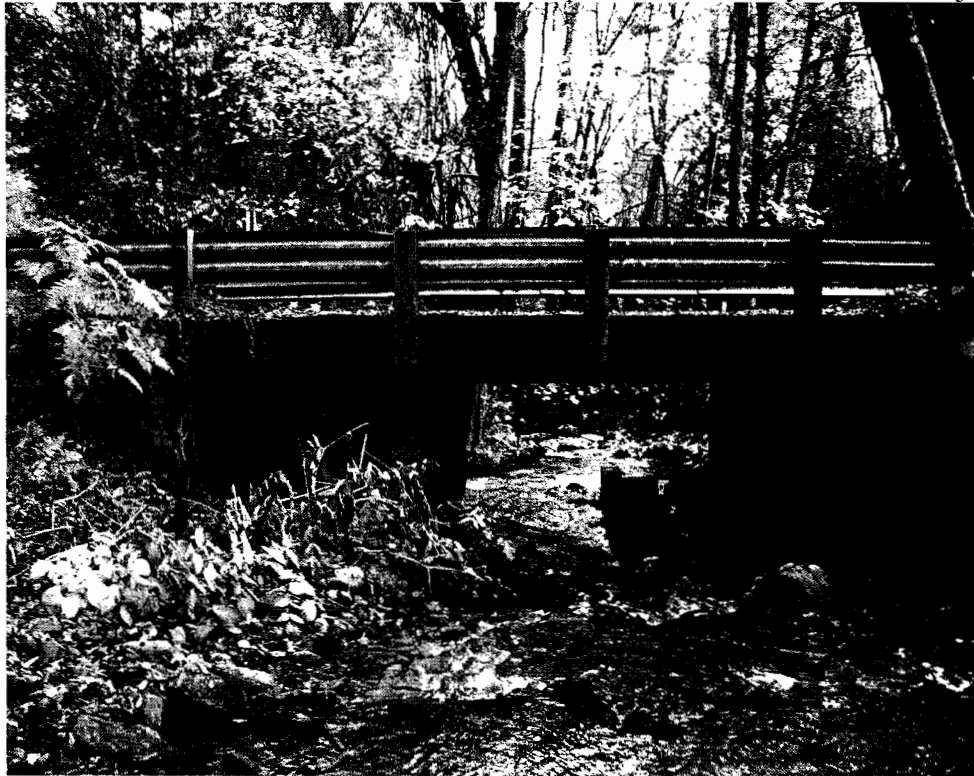
Connor Creek
Crossing #1

Inlet view from
above

Looking
downstream

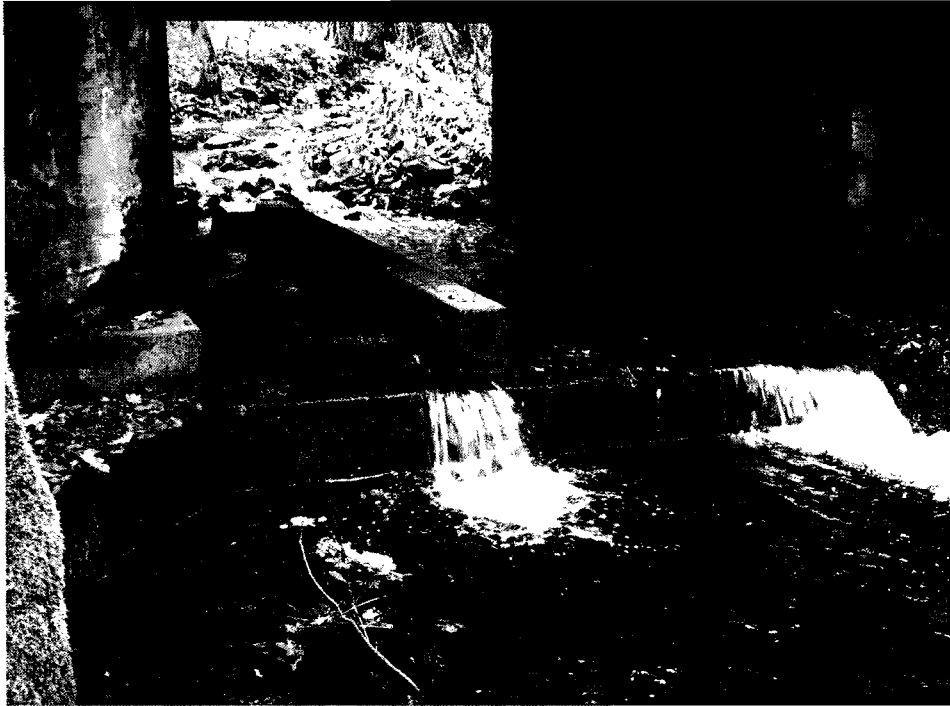
Connor Creek
Crossing #1

Close-up of outlet
drop and pool

Looking Upstream

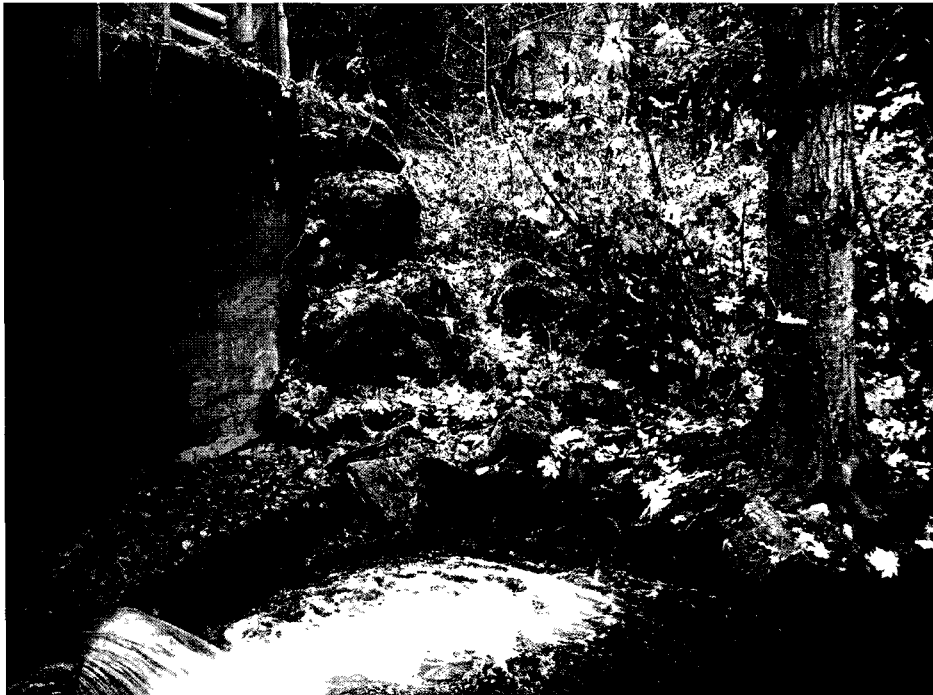
Connor Creek
Crossing #1

Outlet apron and
pool
